SAFETY ALERT

**17th Coast Guard District
United States Coast Guard
P. O. Box 25517
Juneau, Alaska 99802**

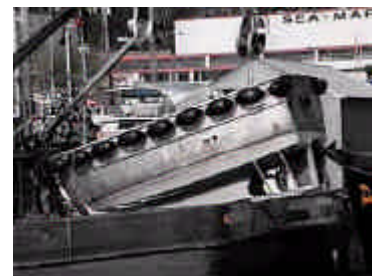
Interviews conducted by the Coast Guard after the accident indicate the EVANICK loaded a 17 foot jet skiff on deck prior to departure. The approximate weight of this skiff was 4500 lbs. Adding this much weight high on deck of the EVANICK would have two results. First, freeboard would have been reduced. Any reduction in freeboard reduces the amount of energy left to recover from heeling forces. For example, prior to loading a skiff, a vessel could potentially recover from a 30 degree roll, with a skiff on deck she could only recover from 20 degrees of roll. This of course becomes critical when the vessel is exposed to excessive heeling forces created by wind and waves. Second, putting weight high on deck reduces the distance between the center of gravity and the meta center of the vessel. This decreases what's called the metacentric height of a vessel and is what naval architects and vessel designers use to measure a vessel's intact stability. If water from a following sea was able to board the skiff, EVANICK's problems would have been compounded.

Large seine skiff stored on deck.

It is important for fishermen to understand the limitations of their vessels. Many hull types are used in the Alaskan seine fleet, hull forms like EVANICK, as well as deep full keeled displacement hulls designed for deep water and heavy weather use. More and more seiners are being used to pursue multiple fisheries year round in Alaskan waters. Many seiners have been modified and altered in ways that can have detrimental effects on stability. Vessels like EVANICK are being used far from shore and often make long transits across open sea to reach fishing grounds. When operating small boats it's important to plan trips based on weather information and to plan for extra time and routes that allow for safe harbor. And of course Fishermen should be thoroughly familiar with their vessels performance limitations and handling characteristics.
